Facility Master Plan

Malheur National Forest

December 2017 - DRAFT

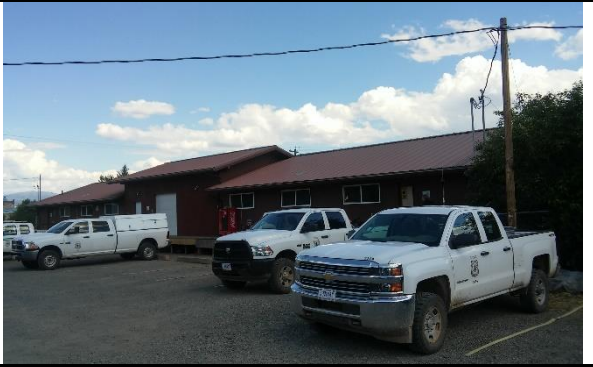
PRAIRIE CITY SC - WAREHOUSE					2210
Recommendation:		Retain for Existing Use

GSF	CRV	DM	COND	YR CONST	
4096	\$561,562	\$54,984	FAIR	1964	
Other:

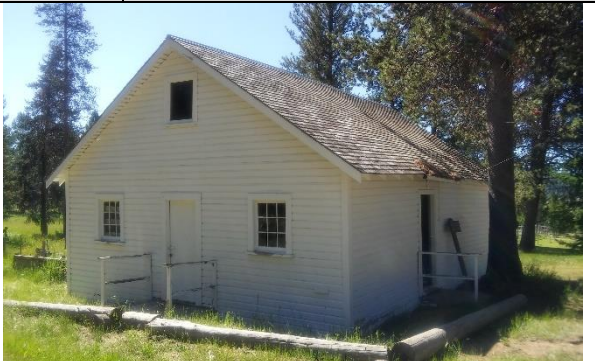
CRANE PRAIRIE WC - BARN					2401
Recommendation:		Retain for Alt Use - Heritage*

GSF	CRV	DM	COND	YR CONST	
768	\$105,293	\$105,293	POOR	1933	
Other: *Structurally unstable, consult with SHPO with goal for removal after documentation

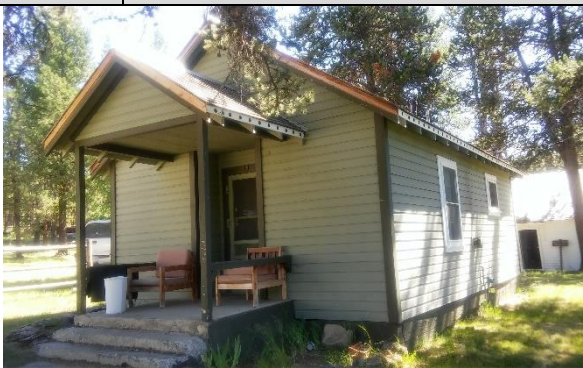
CRANE PRAIRIE WC - BUNKHOUSE					1311
Recommendation:		Retain for Existing Use

GSF	CRV	DM	COND	YR CONST	
504	\$140,961	\$71,968	POOR	1931	
Other:

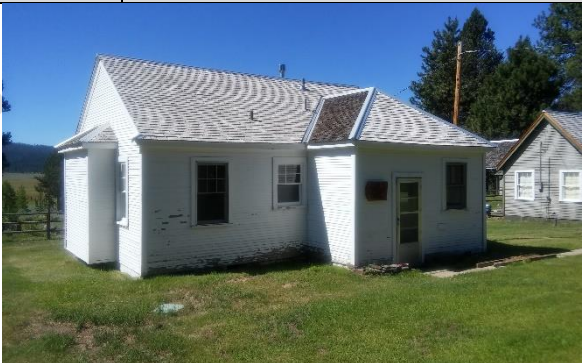
CRANE PRAIRIE WC – BUNKHOUSE (WOMENS)					1008
Recommendation:		Decommission

The Crane Prairie Work Center is about 25 miles southeast of Prairie City, OR. The site is used approximately 5 months of the year for fire suppression operations. The site is mission critical for fire operations of two engine crews. The site is remote and power is supplied by a propane generator and solar panels. Water is supplied by a USFS water system (well and storage tank) and wastewater is handled with septic tanks and drain fields. There are 13 buildings on the site plus a Conex storage container and solar panels. All the buildings are listed in poor condition in I-Web except the two gas houses, the vault toilet near the helitack pad, and the bunkhouse (#1300) used as the fire engines captain's quarters. All the buildings have extensive deferred maintenance. Rodents and woodpeckers are a severe problem at this site. Fire staffing was reduced this season because the bunkhouse (#1008) normally used for female crew members was condemned and is not safe for occupation.

GSF	CRV	DM	COND	YR CONST	
714	\$199,694	\$24,722	POOR	1933	
Other:

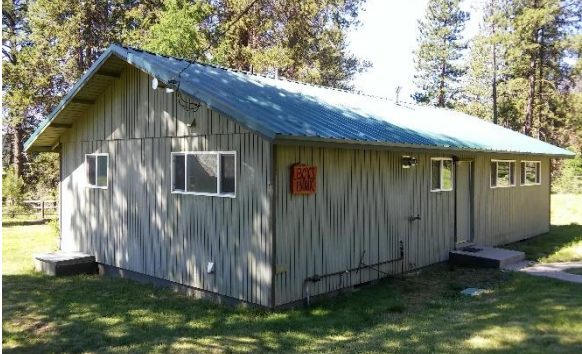
CRANE PRAIRIE WC - BUNKHOUSE					1309
Recommendation:		Retain for Existing Use

GSF	CRV	DM	COND	YR CONST	
1056	\$295,346	\$93,886	POOR	1961	
Other:

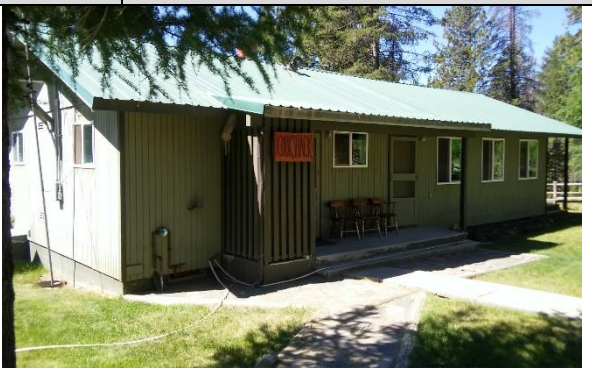
CRANE PRAIRIE WC - COOKHOUSE					1404
Recommendation:		Retain for Existing Use

GSF	CRV	DM	COND	YR CONST	
1272	\$390,636	\$140,358	POOR	1961	
Other:

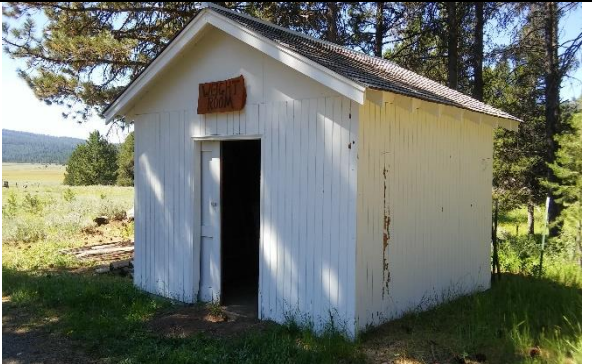
CRANE PRAIRIE WC - STORAGE					2605
Recommendation:		Decommission

GSF	CRV	DM	COND	YR CONST	
200	\$18,097	\$14,637	POOR	1964	
Other:

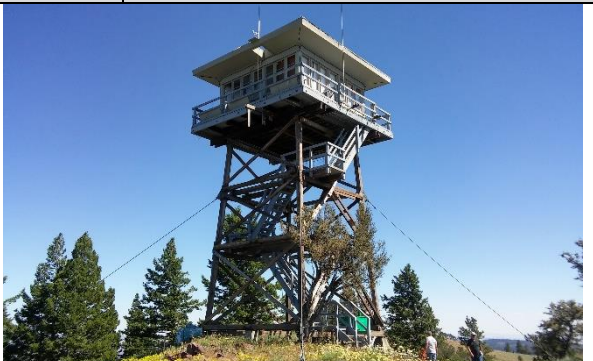
ANTELOPE LO - RESIDENCE					4215
Recommendation:		Retain for Existing Use

The Antelope lookout is R-6 flat cab sitting on a 30-foot treated timber tower. The cab was moved from Lake Butte to the tower in 1974. The lookout is staffed for about 4 months during fire season. The building is in poor condition. The guy wires and railing are loose. The building and the deck around the cab need painting and repairs. Some of the bracing members are split. The flat roof should be replaced. The lightning protection system should be checked for continuity and reliability. The propane system and tank need to be upgraded. There is a newer CXT toilet building in good condition that is not in the I-Web data base. There is also an old wooden toilet on the site and a 6' x 6' fiberglass communication building with a wood floor that is rotted.

GSF	CRV	DM	COND	YR CONST	
441	\$115,481	\$25,089	POOR	1963	
Other:

- Complete a structural inspection of the lookout and tower by a qualified structural engineer
- Complete an inspection of the lightning protection by a qualified contractor to ensure the safety of the system
- Upgrade the propane system and tank
- Tighten the guy wires and repair any structure deficiencies
- Replace the lookout flat roof with a membrane roof with a slight build up for drainage and suitable for the weather conditions (EPDM or similar material)
- Decommission the old wooden toilet (#1741) by disposing off site
- Replace the fiberglass communication building and add the new buildings without numbers to the I-Web database

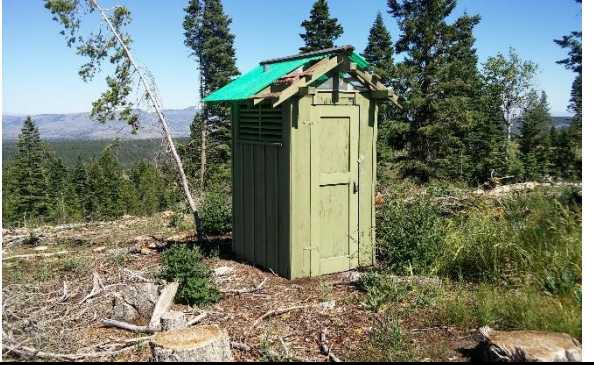
ANTELOPE-TOILET					1741
Recommendation:		Decommission

GSF	CRV	DM	COND	YR CONST	
16	\$6,954	\$715	FAIR	1963	
Other:

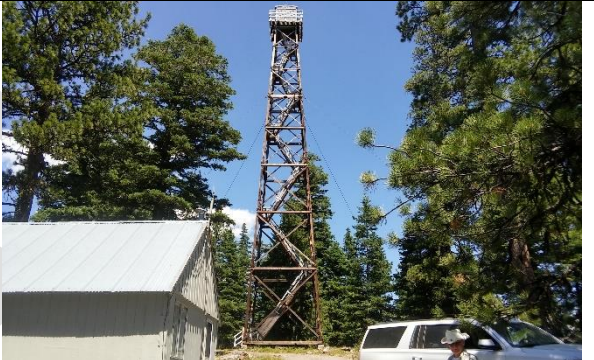
FRAISER LO – CAB (Correct I-Web spelling to Fraizer)					4211
Recommendation:		Decommission

The Frazier Lookout is a 7-foot by 7-foot cab on a 100-foot treated timber tower. The lookout is no longer staffed and the structure is condemned due to structural deficiencies. There is a residence on the ground at the site and a small toilet. The residence and toilet are in poor condition. The buildings have significant deferred maintenance and would require extensive upgrading to be safe for occupants.

GSF	CRV	DM	COND	YR CONST	
49	\$12,831	\$12,831	POOR	1936	
Other: I-Web Spelling is incorrect, should be Fraizer

- Decommission all buildings on the site using a salvage based contract
- Secure the site until buildings can be decommissioned to prevent the public from entering the unsafe buildings including climbing the 100-foot tower.

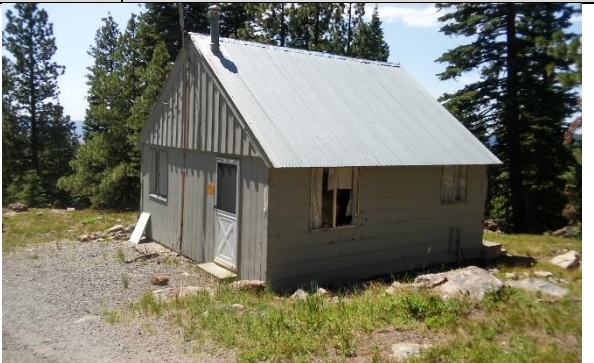
FRAISER LO – RESIDENCE (Correct I-Web spelling to Fraizer)					1508
Recommendation:		Decommission

GSF	CRV	DM	COND	YR CONST	
400	\$111,874	\$111,874	POOR	1938	
Other:
